Degenerated biologic surgical valve fracturing after TAVI implantation

Bunc M., Steblovnik K., Terseglav S., Čerček M., Šušteršič M.
UKC Ljubljana, Slovenia.

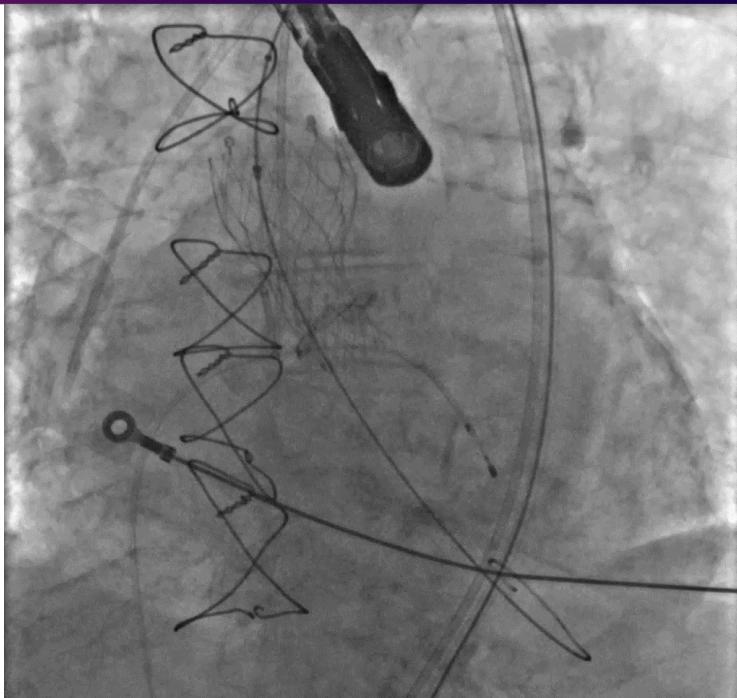
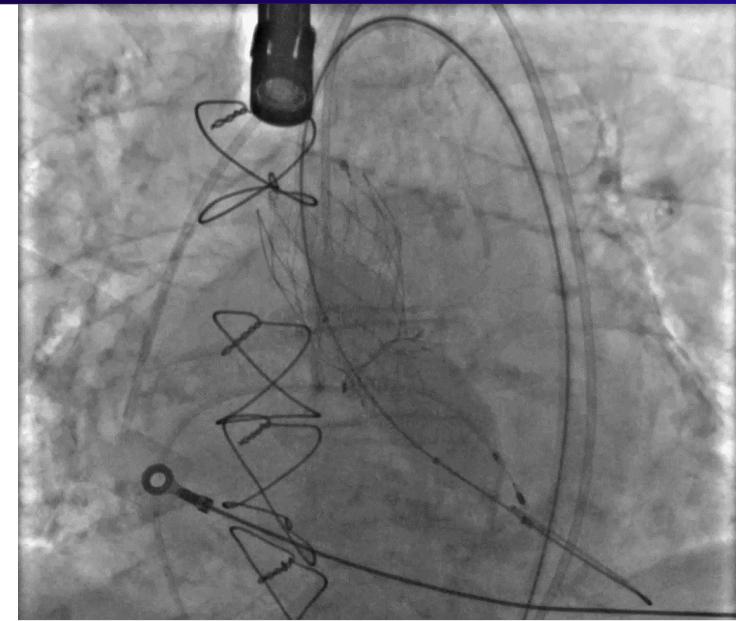
BAV HP balloon 22 mm, 14 atm

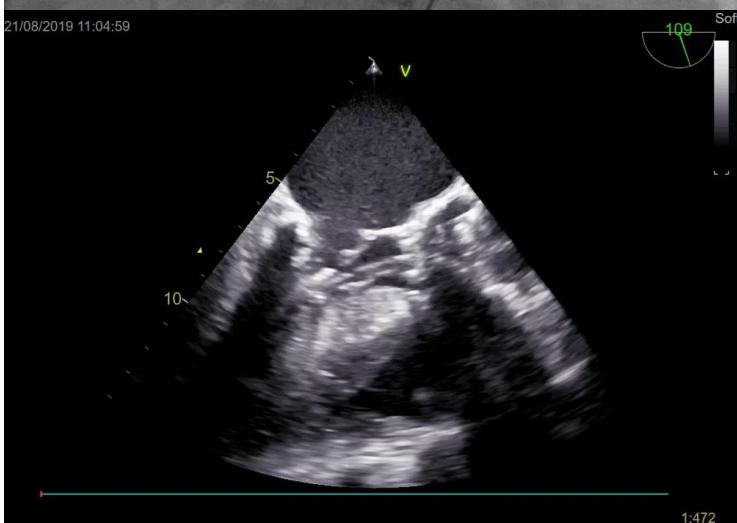
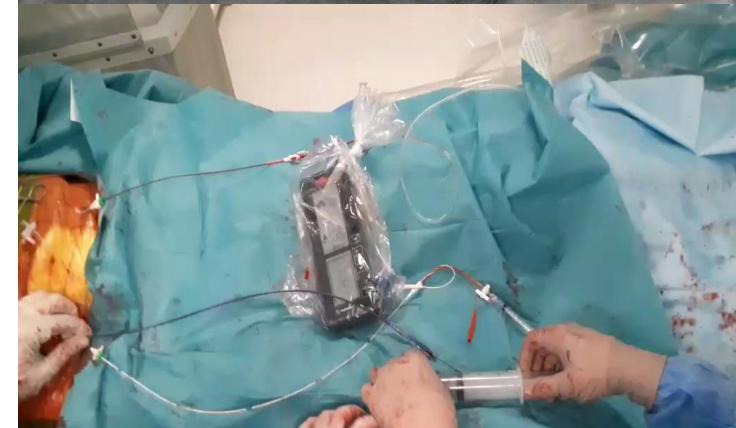
EvR 23 mm in Mitroflow 19 mm: Balloon HR 22 mm.

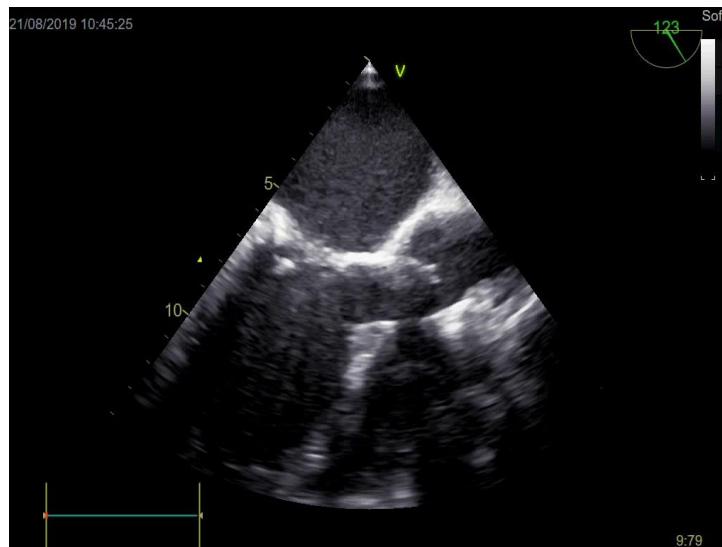
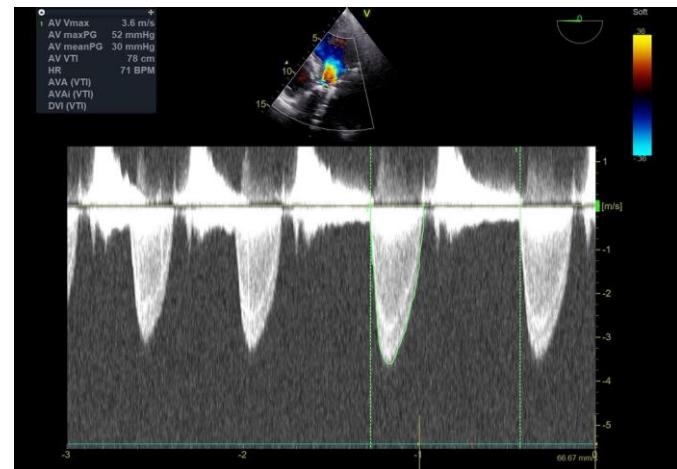
Echocardiography

Vmax 3.6m/s, maxPG 51mmHg, meanPG 31mmHg.

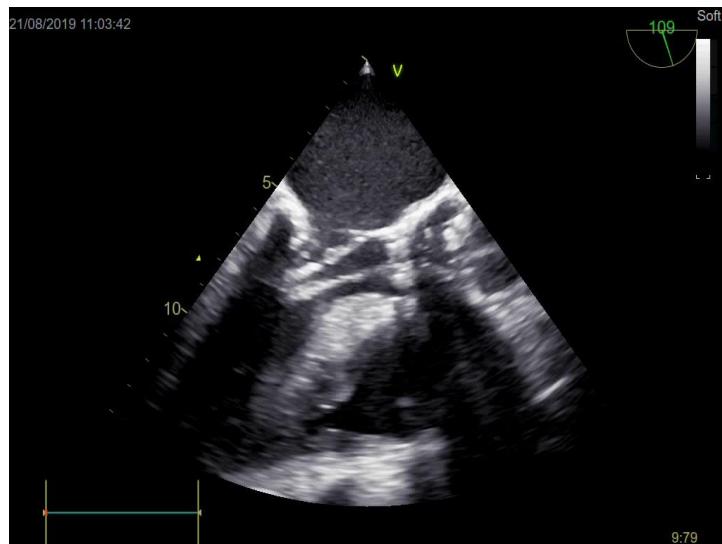
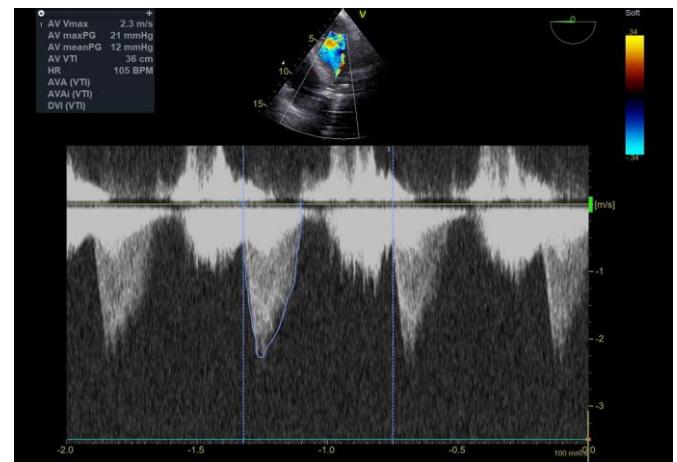
Vmax 2.5m/s, maxPG 25mmHg, meanPG 13mmHg.
