When one valve isn't good enough

Department of Cardiology
Mater Dei Hospital, Malta

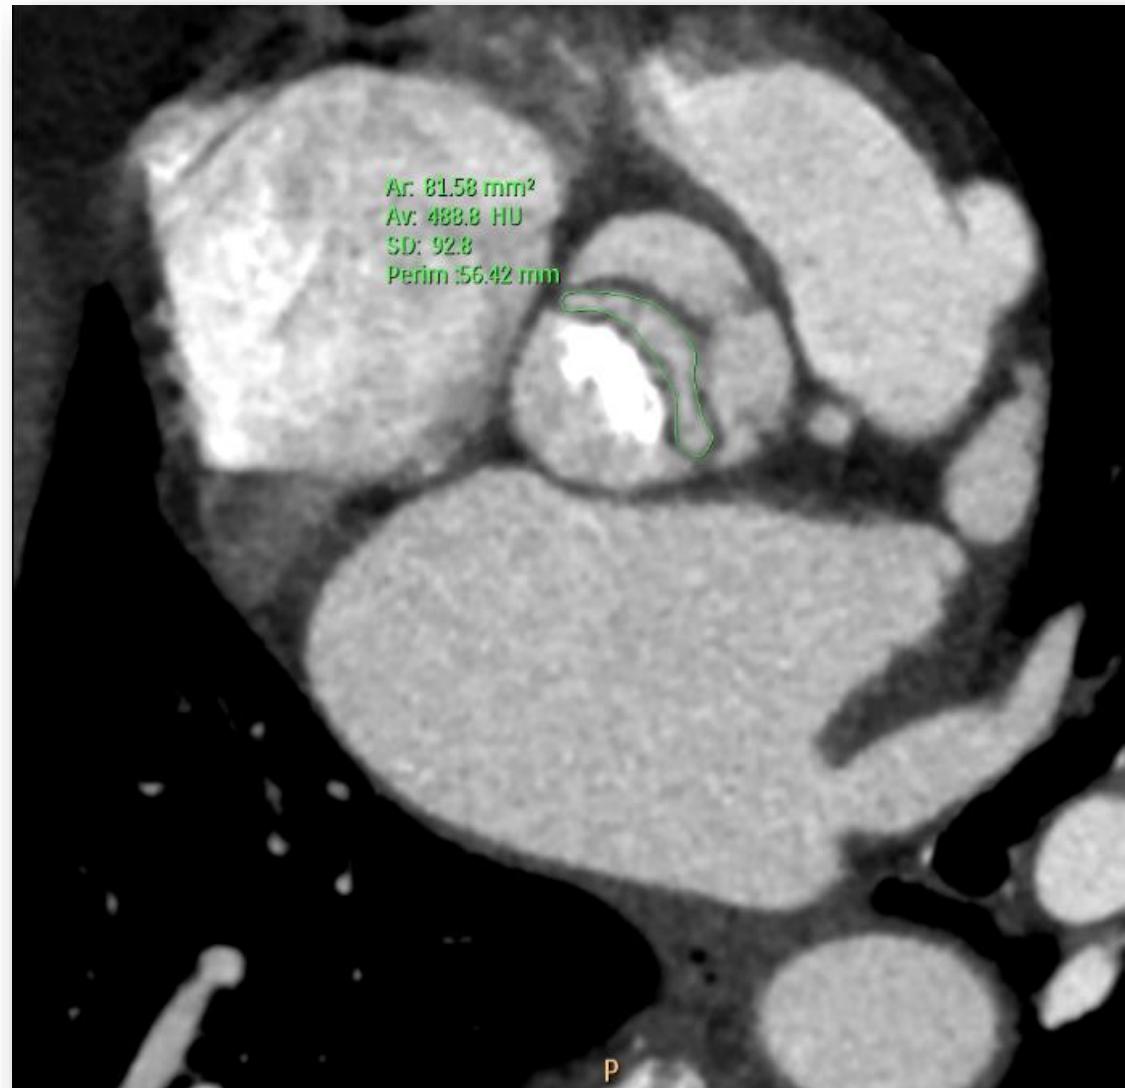
- Bicuspid aortic valve (Sievers classification type 1 R-L)
- Severe calcification of leaflets and annulus
- Calcified plaque near ostium of left main stem
- Height LCA ostium 10.4mm
- Height RCA ostium 15.7mm

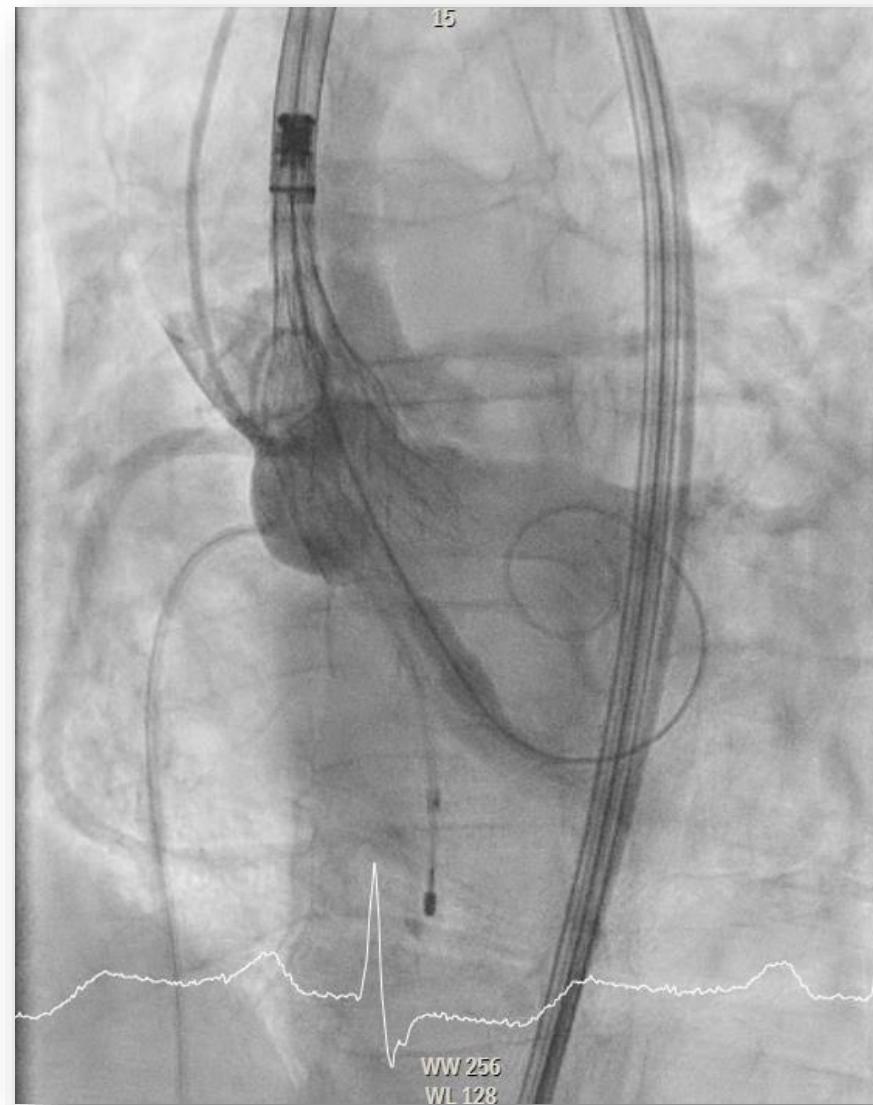
TAVI procedure: Prior to deployment

Transfemoral TAVI
under deep
sedation

26mm CoreValve
Evolut R device
position prior to
deployment

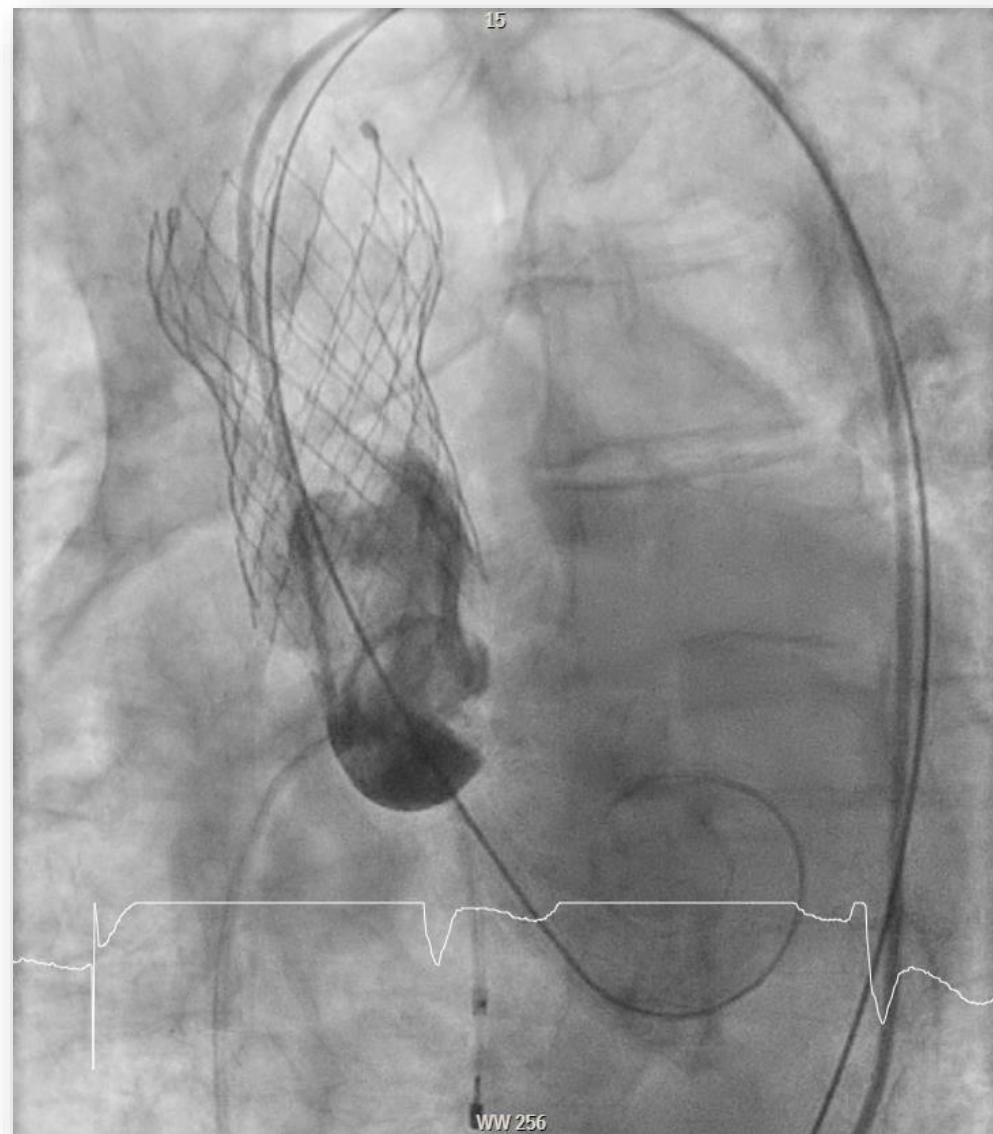
TAVI procedure: Post deployment

TAVI device popped up into ascending aorta immediately after deployment

Severe aortic regurgitation noted

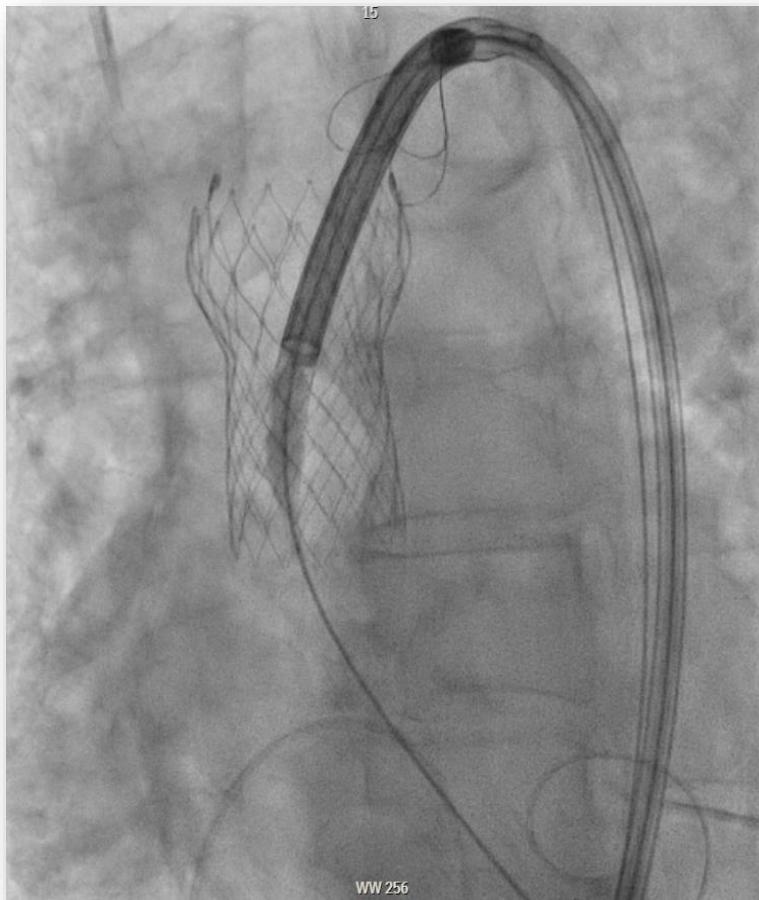
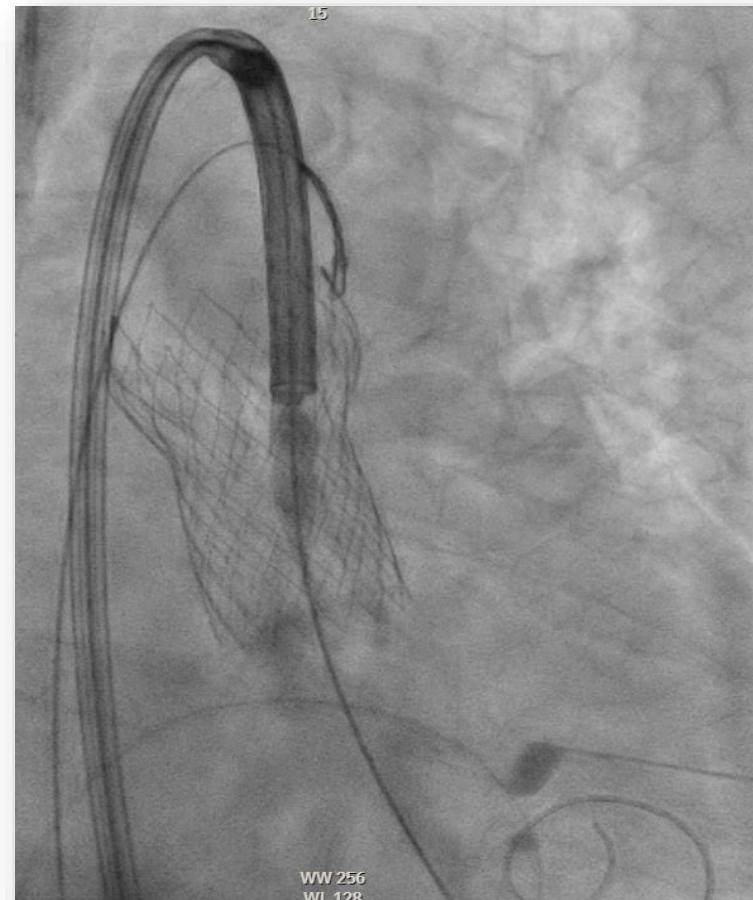
Device was snared and pulled up to avoid blocking the coronary ostia

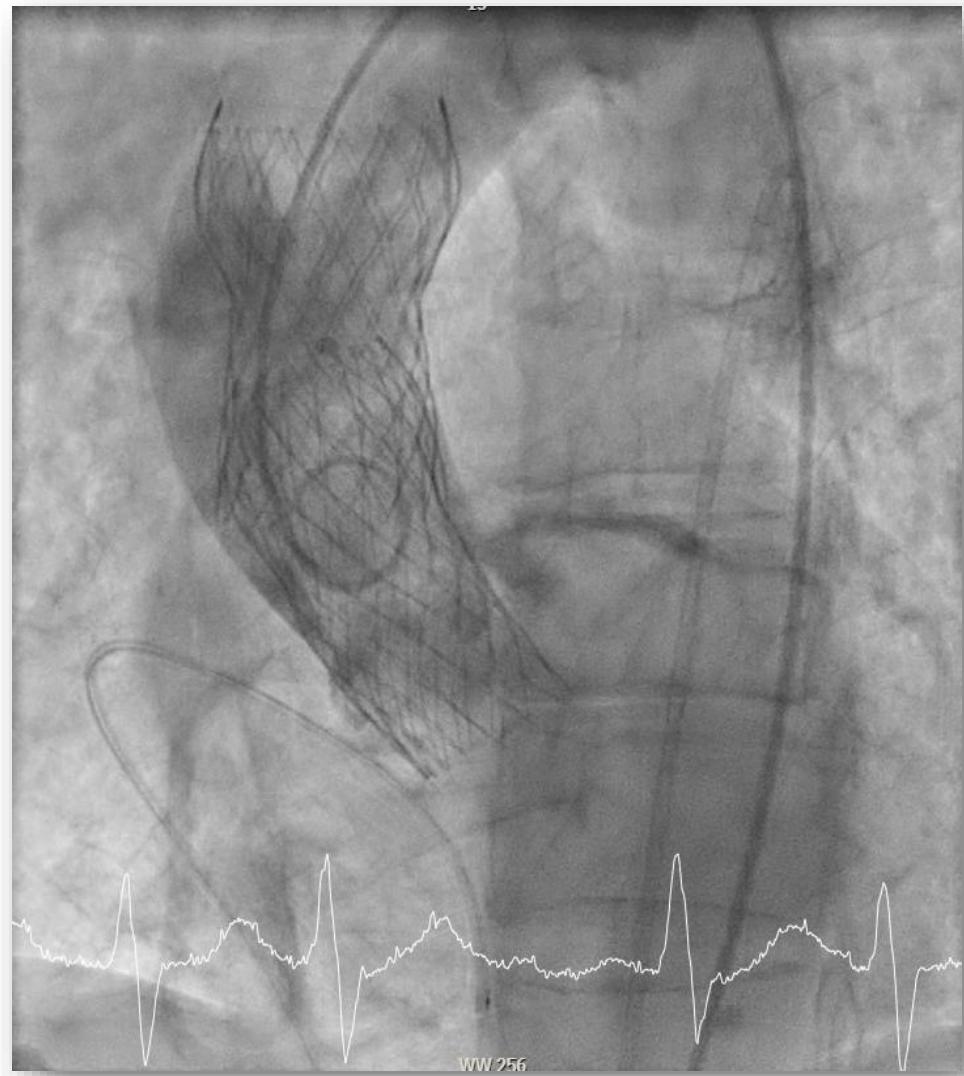
Deployment of second TAVI device

Second device deployed inside the first device, in slightly lower position than the first device

Postdilation with 18mm, followed by 20mm balloon

Slight residual paravalvular leak

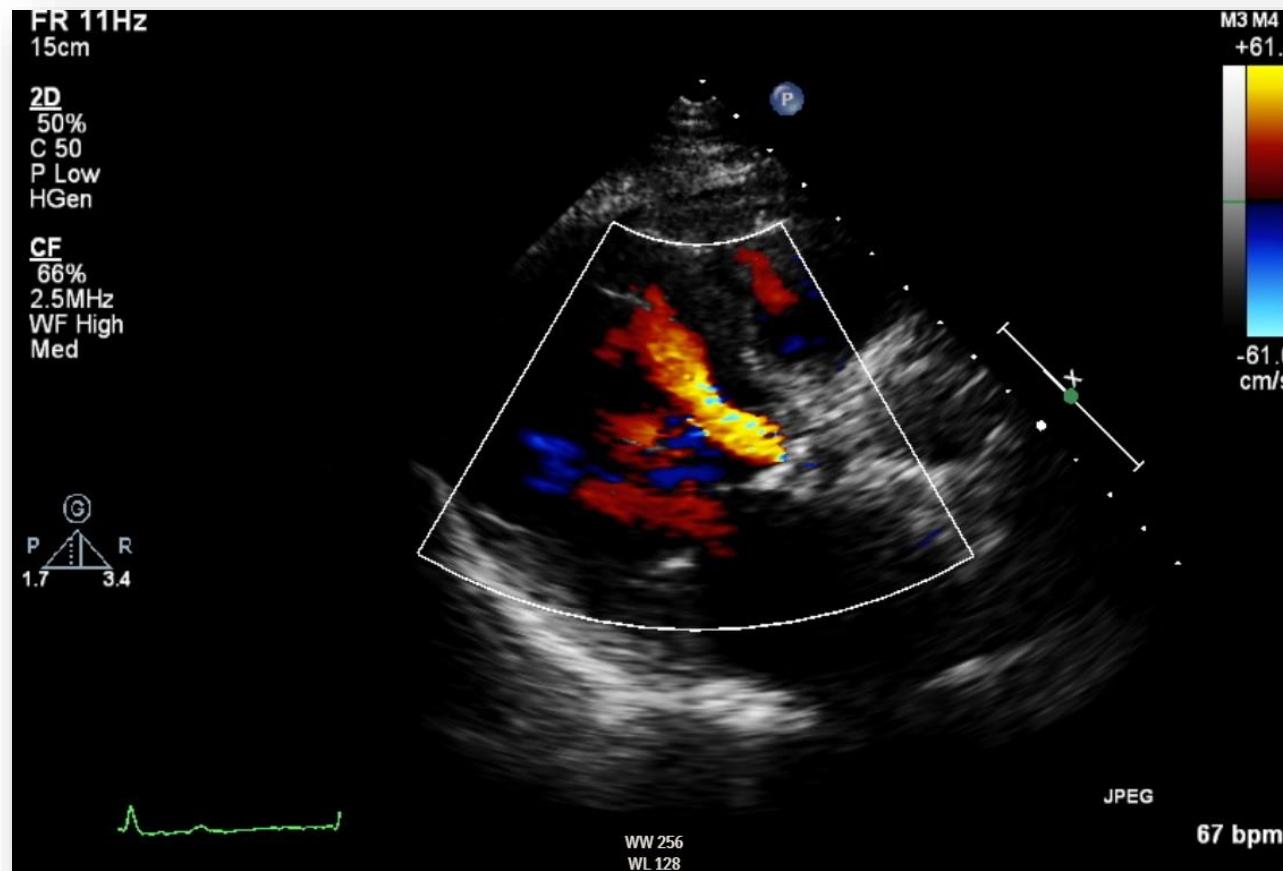
TAVI devices in situ
Moderate paravalvular leak
