The underexpanded stent remains an  
undefeated enemy

75 y/o male, stable angina CCS 2, prior CABG

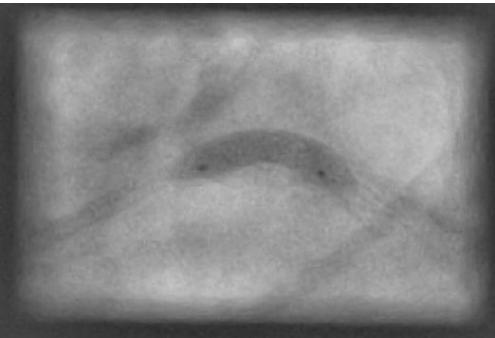
Non-compliant balloon  
3.5x15 mm, 3x 26 atm

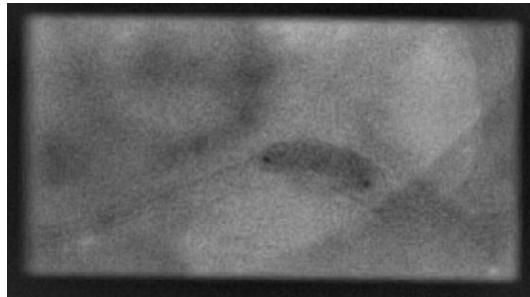
Lithoplasty balloon  
3.5x12 mm, 4 atm + 6 atm  
1<sup>st</sup> cycle

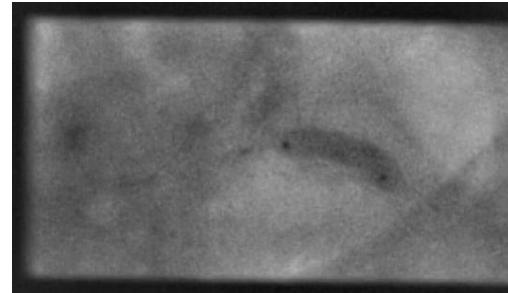
2<sup>nd</sup> cycle

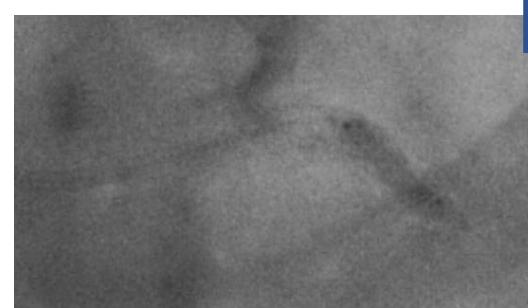
3<sup>rd</sup> cycle

4<sup>th</sup> cycle  
**RUPTURE** at 6 atm

- The lithoplasty balloon can rupture, although following the instruction for users.
- A possible cause might be balloon laceration by pointed calcifications or overhanging struts of underexpanded stents.
- Adequate lesion preparation prior to stent implantation is mandatory.
- The management of an underexpanded stent is more difficult than proper lesion preparation before stent implantation.
- Imaging and stent enhancing technology help to understand the lesion.

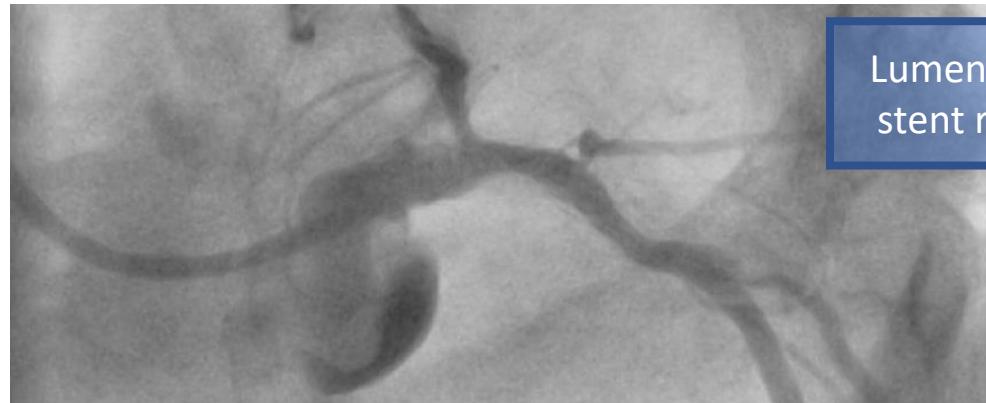
Lumen gain achieved, however  
stent remains underexpanded

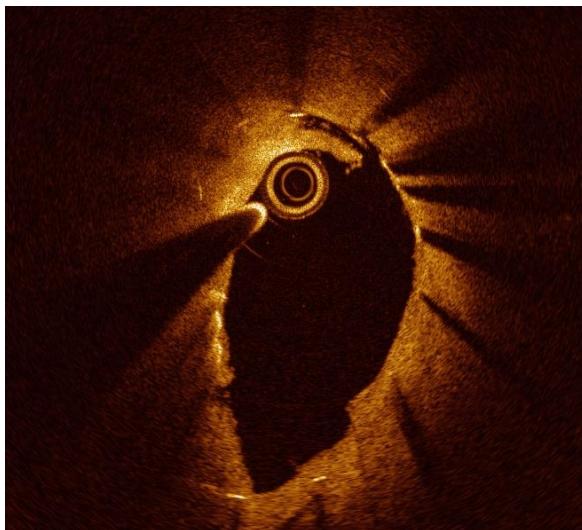
Former site of MLA  
5.1 mm<sup>2</sup>

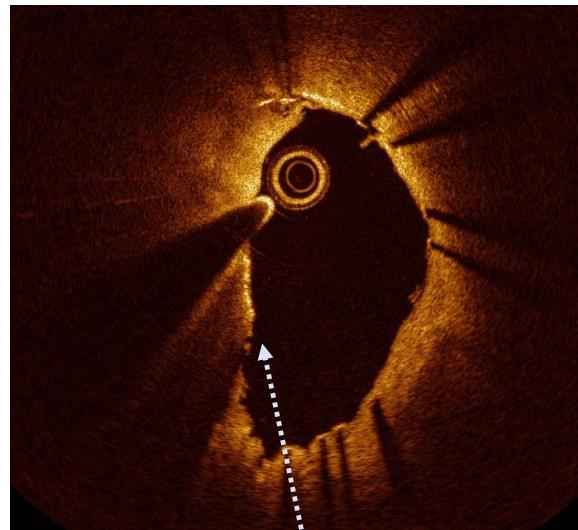
Former site of  
pointed calcification

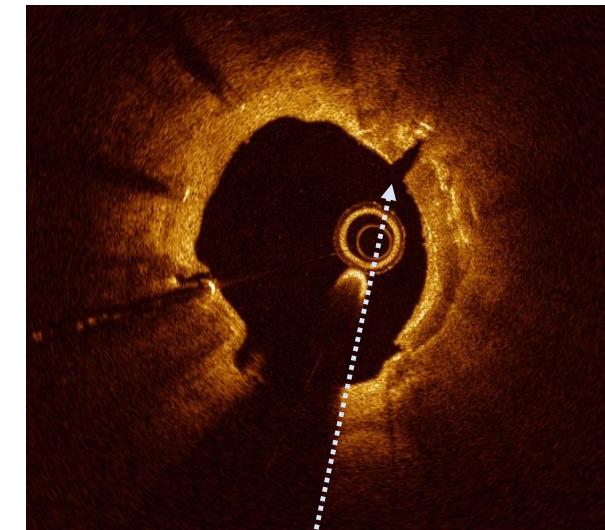
Calc-crack in the old stent  
A sign of proper preparation  
at this site

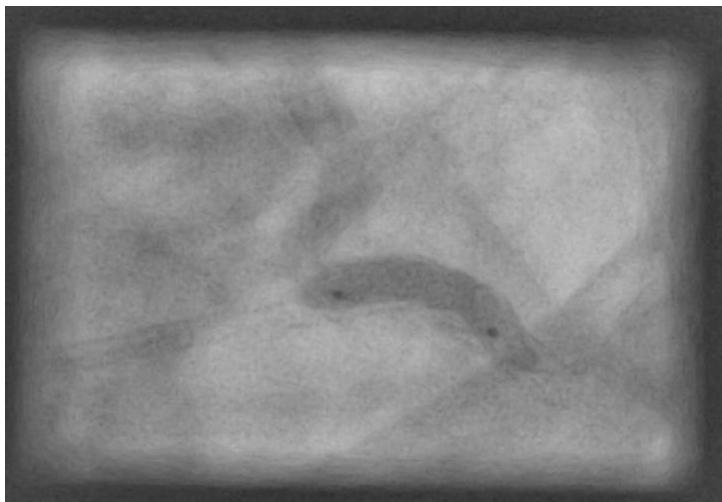
Non-compliant balloon  
3.5x15 mm, 3x 26 atm

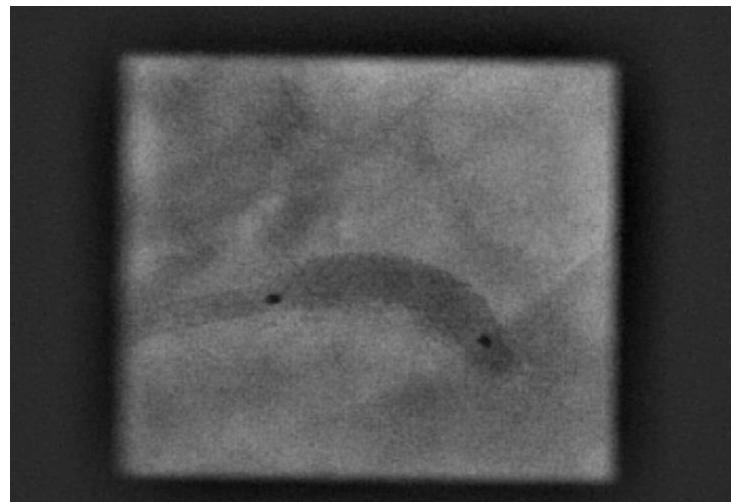
2x drug coated balloons  
3.5x20 mm, 2x 26 atm, 2x 45 seconds

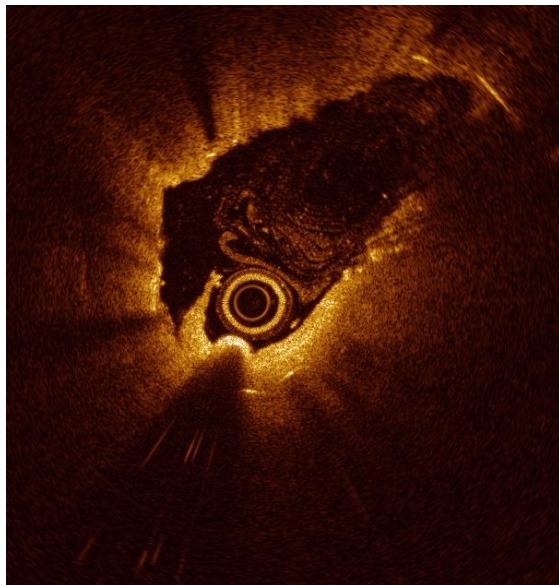
Former site of MLA  
5.5 mm<sup>2</sup>

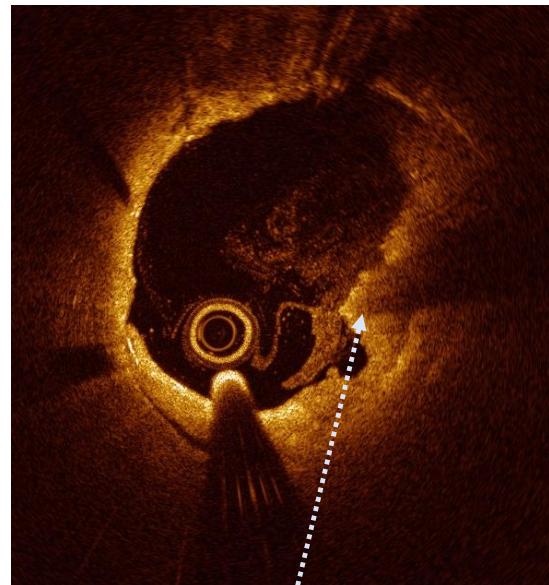
Former site of pointed calcification

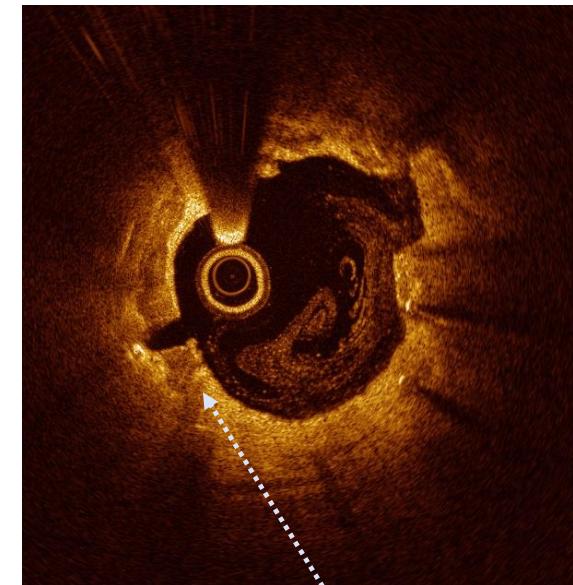
Calc-crack in the old stent

We accepted the intimal tear and did not implant an additional DES to avoid stent in stent
